REPORT DOCUMENTATION PAGE		READ INSTRUCTIONS BEFORE COMPLETING FORM
1. REPORT NUMBER Appendix V to the O&M Manual Longview Lake	2. GOVT ACCESSION NO.	3. RECIPIENT'S CATALOG NUMBER

4. TITLE (and Subtitle) Multiple-Purpose Project; Little Blue River Basin Little Blue River, Missouri Longview Lake Operation and Maintenance Manual; Appendix V Embankment Criteria and Performance Report	5. TYPE OF REPORT & PERIOD COVERED Embankment Criteria and Performance Report Sep 79 to Sep 90

9. PERFORMING ORGANIZATION NAME AND ADDRESS Dams and Foundations Section (CEMRK-ED-GD) Geotechnical Branch (CEMRK-ED-G) U.S. Army Corps of Engineers, Kansas City District 601 E. 12th Street, Kansas City, MO 64106	8. CONTRACT OR GRANT NUMBER(s)

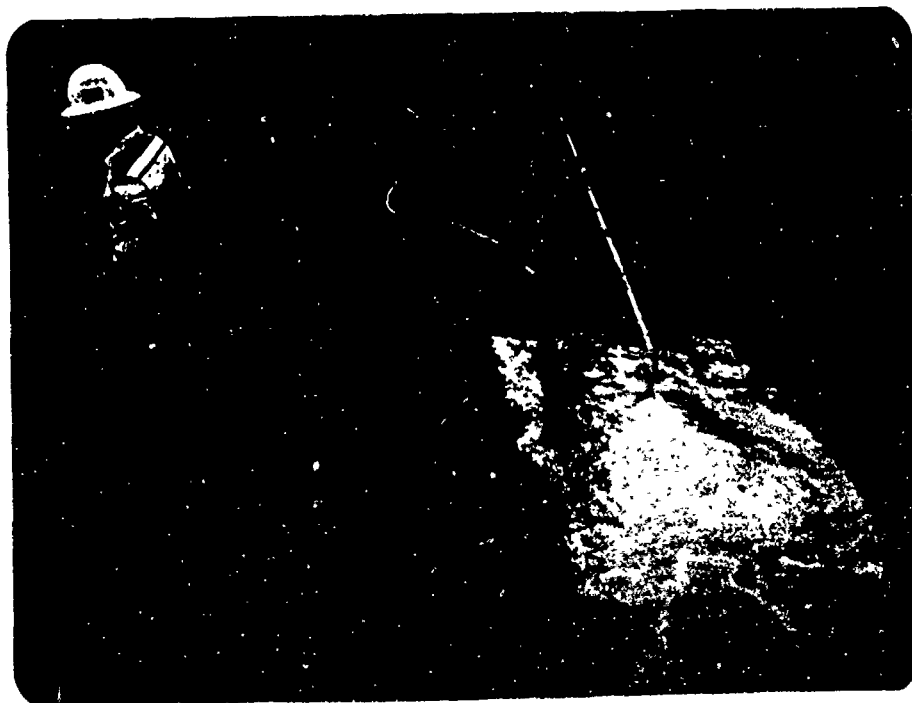
19. 14 August 1980. Placement of dental concrete and slush grout to seal the surface of Middle Creek limestone of the right abutment. Looking downstream.

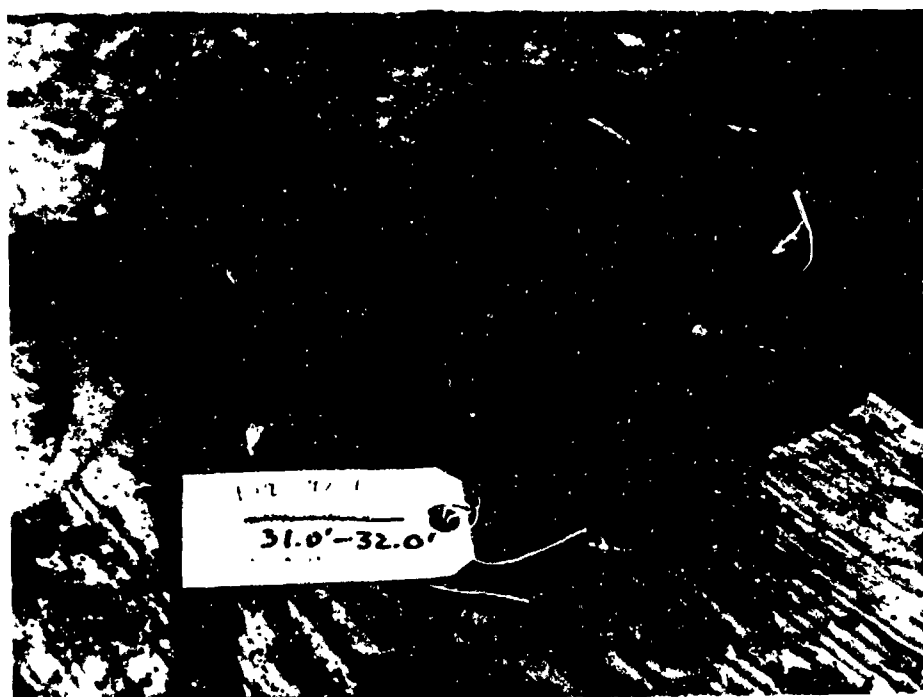
27. November 1982. Sample showing typical smooth surface texture, probably caused by pumping action of loaded scraper; PPE-97-15, Depth 31-32 feet; Elevation 837.7 to 838.7.

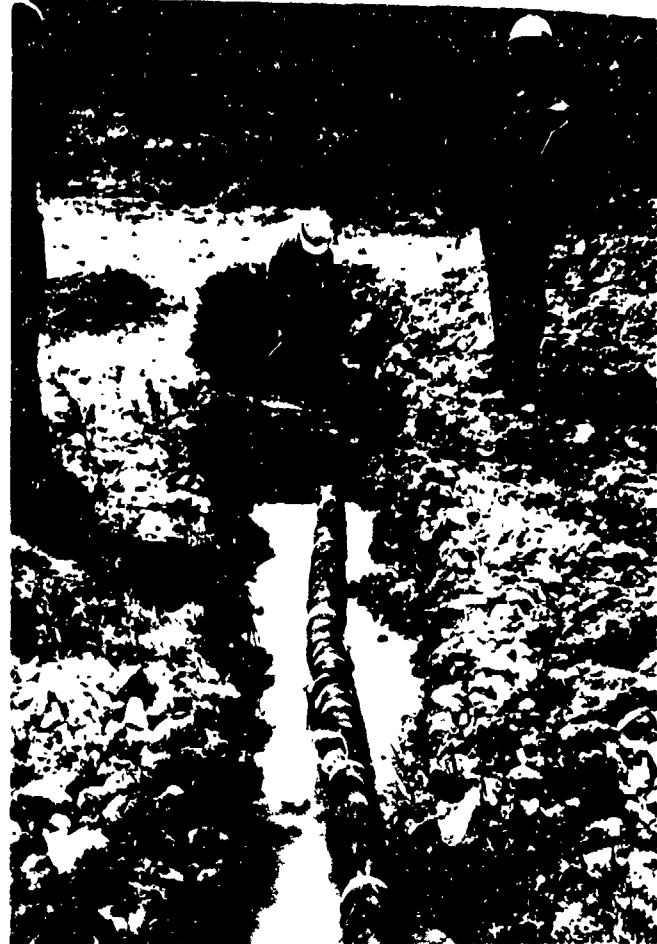
65. 19 May 1986. Installation of finger drains into pervious blanket at embankment toe.

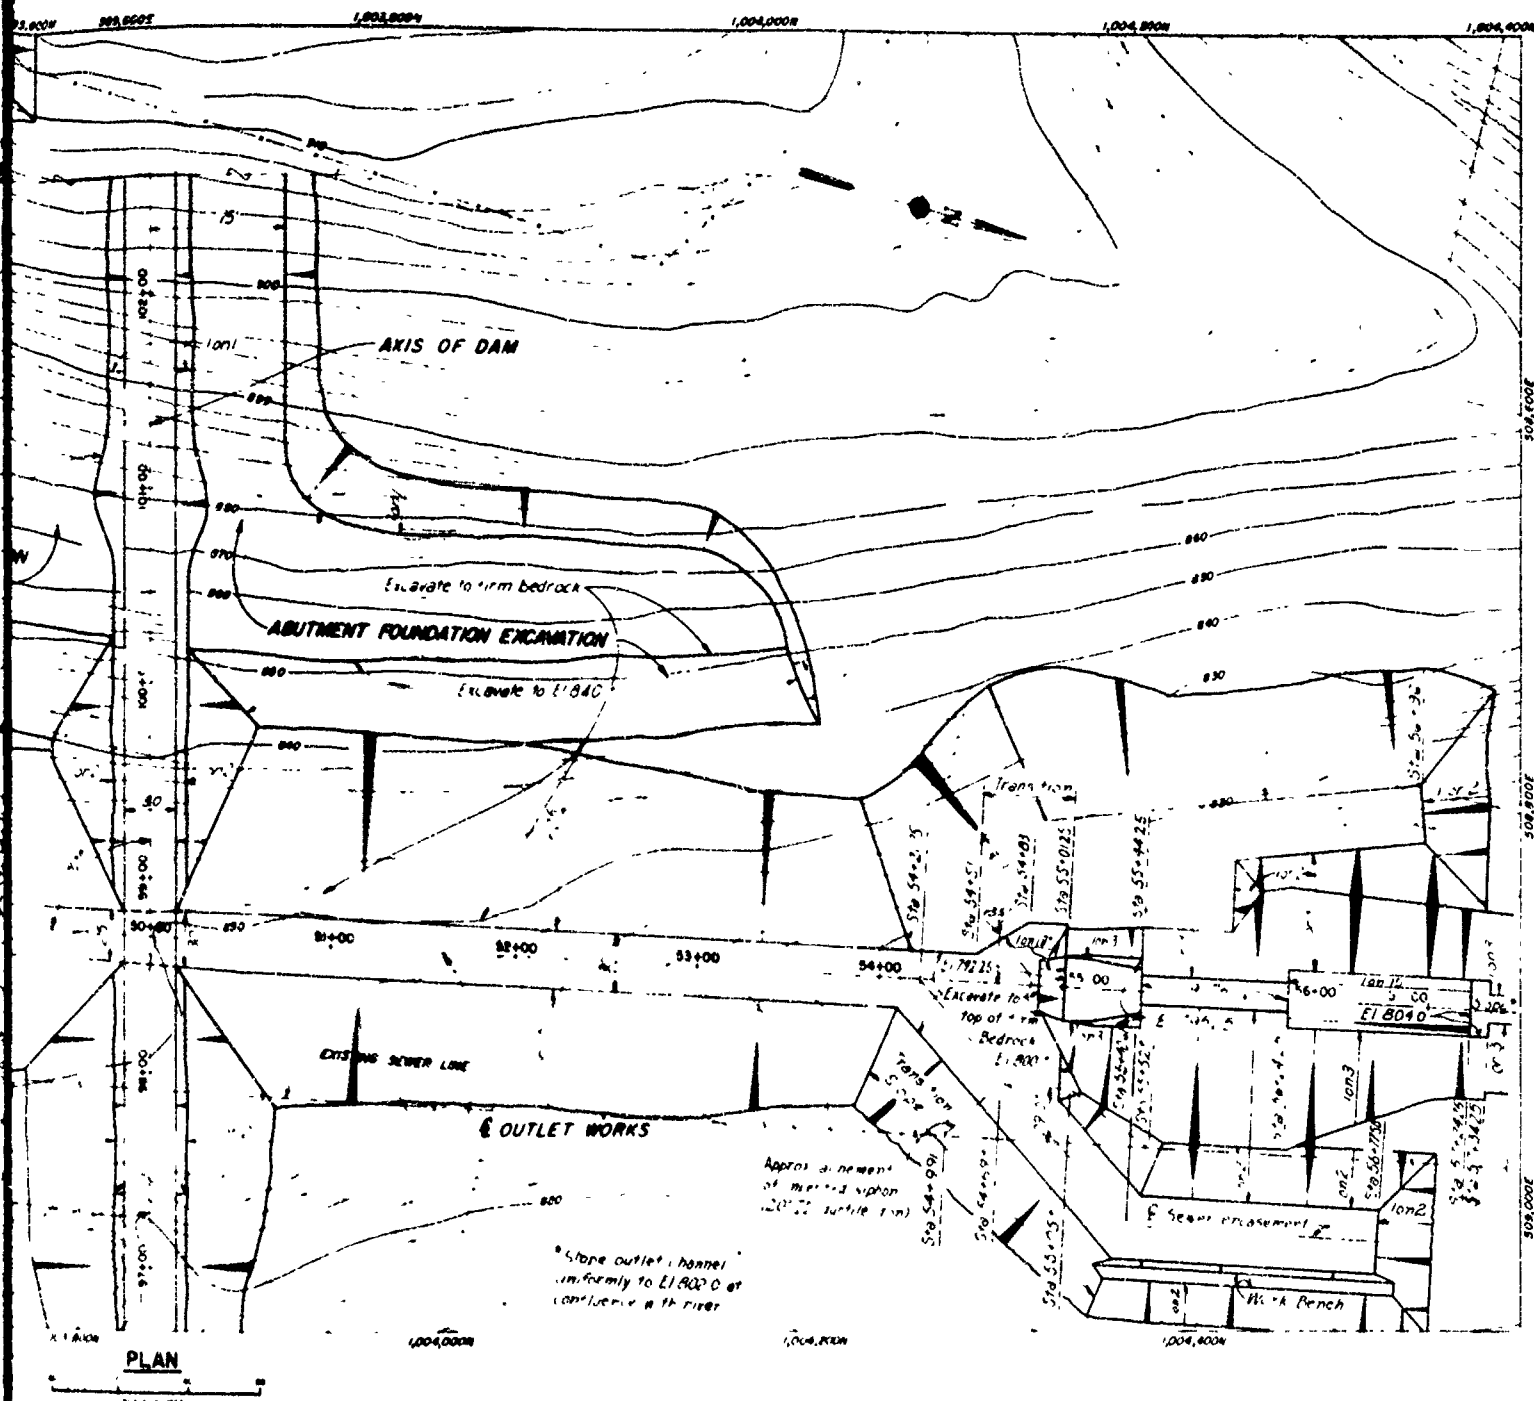
PLATE NO. 11

1. Additional excavation was required in the vicinity of Outlet works Sta 52+00, left Bank, to remove the land slide material at
 - A 20,000 cu yds of slide material removed
 - B 20,000 cu yds of additional impervious backfill
 - C Additional clearing and grubbing required
